REPORTS ON WORK AT MONAGRI, LAGOUDERA, AND HAGIOS NEOPHYTOS, CYPRUS, 1969/1970

DAVID C. WINFIELD

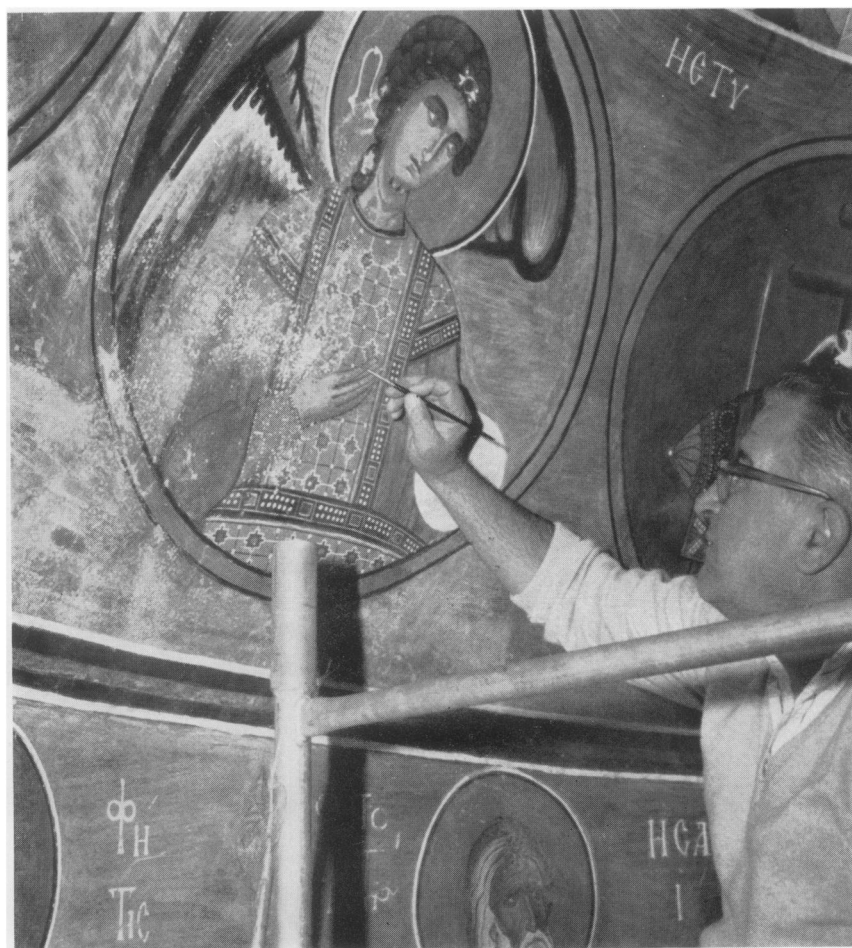
11. Work in Progress on Roundel of Angel
Lagoudera, Panagia tou Arakos, Dome

10. Head of Angel

Work on the paintings continued in the central and western areas of the naos, and by the end of 1970 the cleaning and consolidation of the center of the naos was completed, with the exception of the ground registers (figs. 10, 11). At the west end of the naos the Nativity in the south side of the vault, a series of medallions in the center of the vault, and part of the west end of the south wall were cleaned. Consolidation of these areas where necessary was effected by injections of a filler of slaked lime and polyvinyl acetate emulsion.

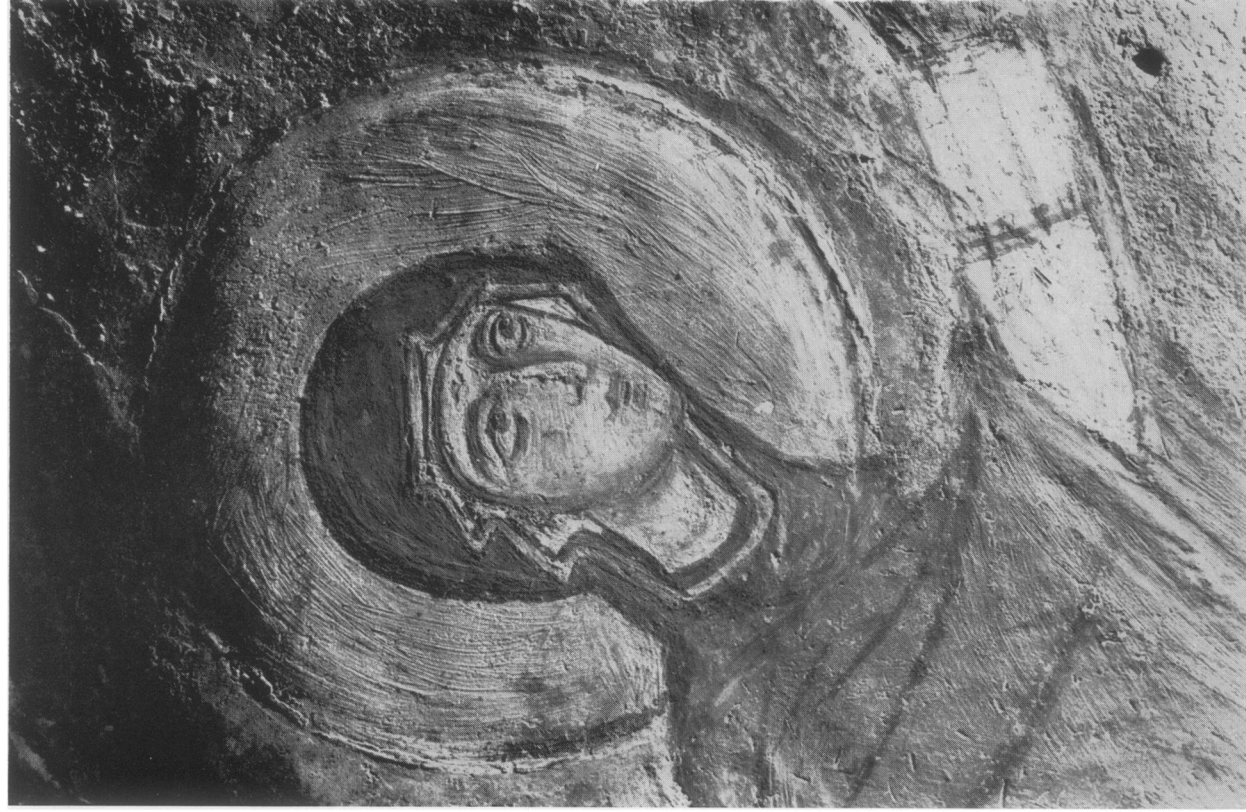
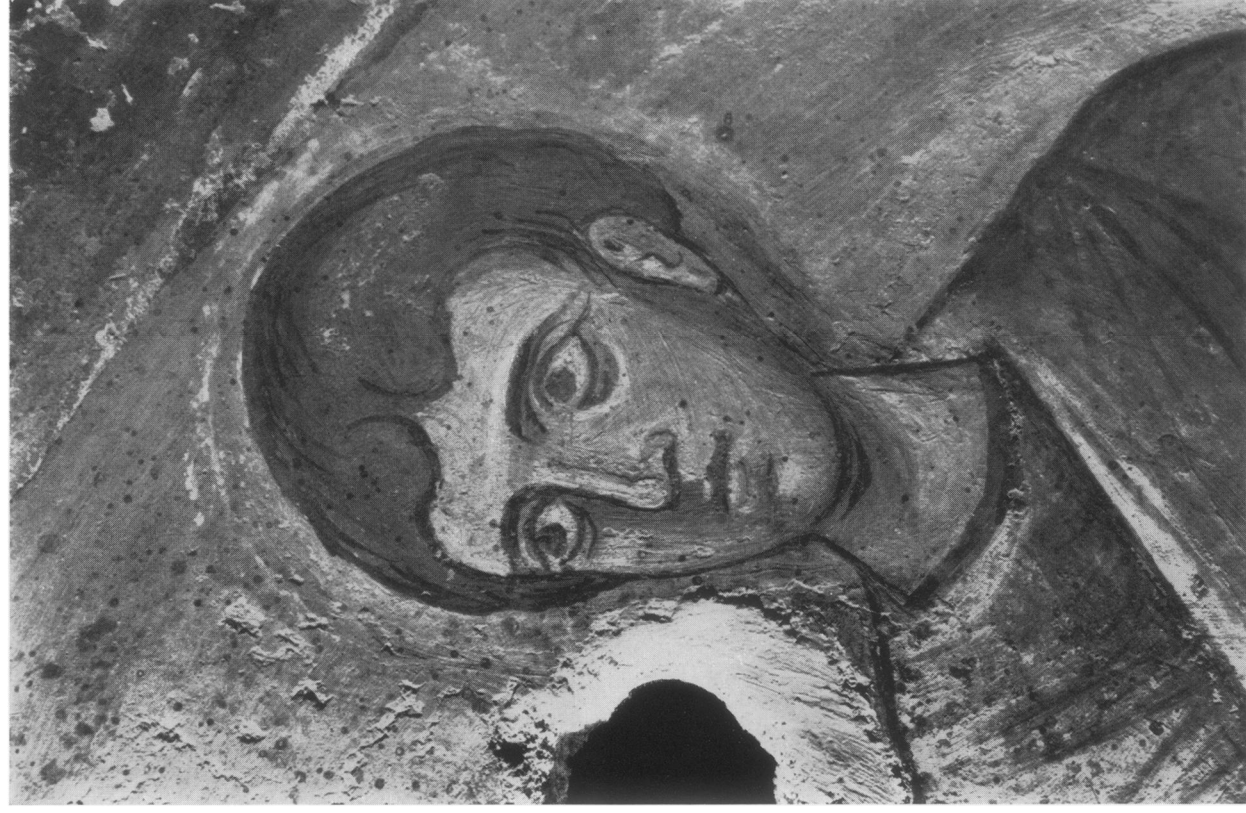
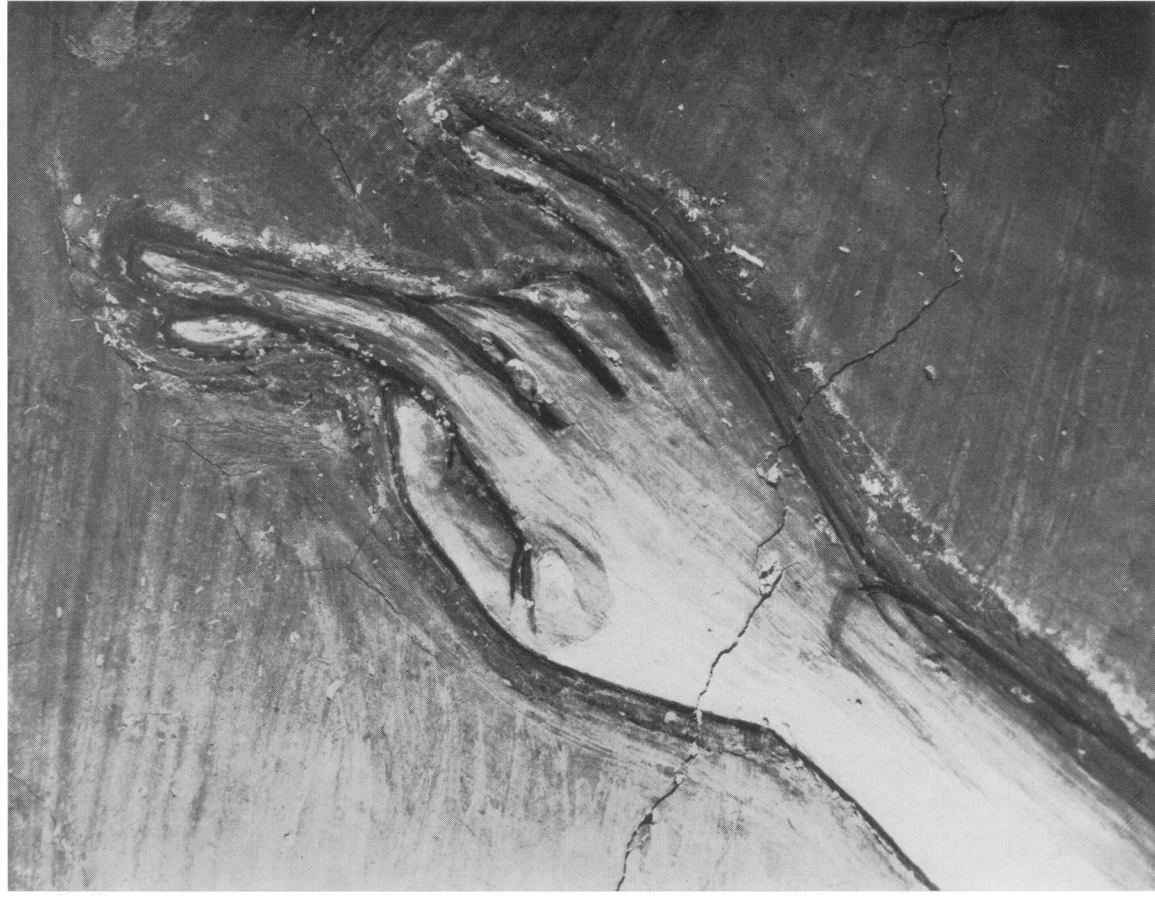
21. Head of the Mother of God, detail, to show Working of Plaster around Head

22. Head of an Apostle, detail, to show Plaster around Head. This plaster is either a fresh patch or has been reworked before Painting of Head.

23. Paphos, Hagios Neophytos, Bema. Ascension, the Mother of God, detail, to show Working of Plaster around Hand

24. Lagoudera, Panagia tou Arakos, Dome. The Prophet Habakkuk, detail, to show Working of Plaster around Hand

The close stylistic relation of some of the paintings in the bema and cell of St. Neophytos to those at Lagoudera was noticed by Professor Mango and Mr. Hawkins.⁸ To this stylistic relationship may be added a technical affinity, for there is evidence that one of the painters of the Enkleistra worked his plaster and handled his colors in a manner similar to that used by the Lagoudera master (figs. 21-24).
